The Battle of the Bulge

By David Motley Photos by David Motley and Wes Lambe

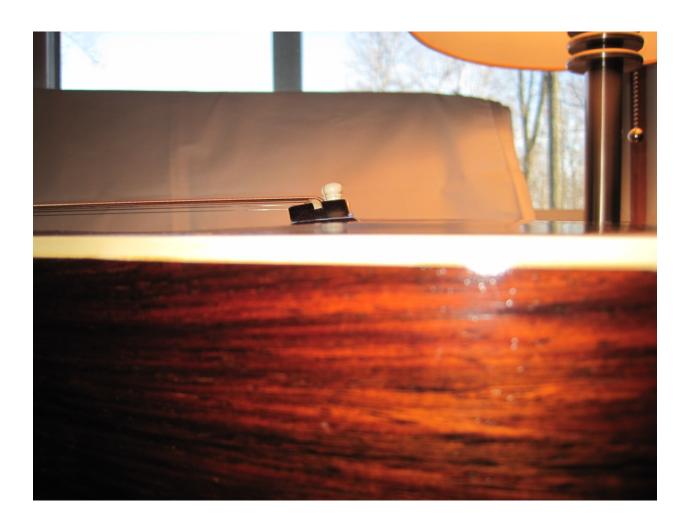
Eighty years under tension and high stepping has taken its toll. There was only a small arched shape below the bridge evident when purchased in 1994, but that shape has steadily increased with age and use during my 18 years of stewardship. Over the most recent 2 years of playing, that bulge has accelerated as evidenced by inconsistent intonation and frequent tuning frustrations.

My technical opinion was that something needed to be done promptly or the increasing bridge elevation and tilt would lead to increasing over-turning moment (string force X bridge height increase) and the exponential result would be catastrophic.

Nick Lucas top belly bulge

A few days after my trip south, Wes emailed me a list of suggested remedial actions intended to reshape the bulged top below the bridge and flatten the dips on each side of the sound hole above the bridge. His physical examination had convinced him that corrective action was necessary to keep this antique alive and functioning. He recommended removal of internal repair braces previously added as after-market repairs, replacing the added unoriginal Mahogany bridge plate (wrong wood with grain going in wrong direction), and adding a thin veneer on the underside of the Spruce top to cover and reinforce the area with a short cross-grain crack in the underside of the top just below the bridge plate. This is not a through crack so it's not visible on the outside of the top. The thin veneer was to be made of the same wood as the top and was to be a small local unequal-4sided shape fitted up to the lower apex of the X-braces and extending down about 3-1/2 inches to the edge of the original transverse brace that is standard top bracing across the lower bout of most steel string "flat top" guitars no matter what brand or boutique. This thin veneer is structurally critical to resist the inherent local overturning moment that caused the top to bulge immediately below the bridge. This overturning moment exists on every guitar top with a fixed bridge. The small veneer was to be glued (hot hide glue) to the underside of the top and captured/glued between the bridge/top/bridge plate layered structure. The replacement bridge plate was to be Maple (like the original Gibson plate) with the wood grain running in the correct direction.

Wes would use his own technique of heat and clamps (after removal of the bridge and bridge plate) to reshape the original top. It is important to recall that these 1930's Gibson flat tops were never flat on top but were made with a slight arched crown, both transverse and longitudinal. I agreed to his assessment and recommendations.

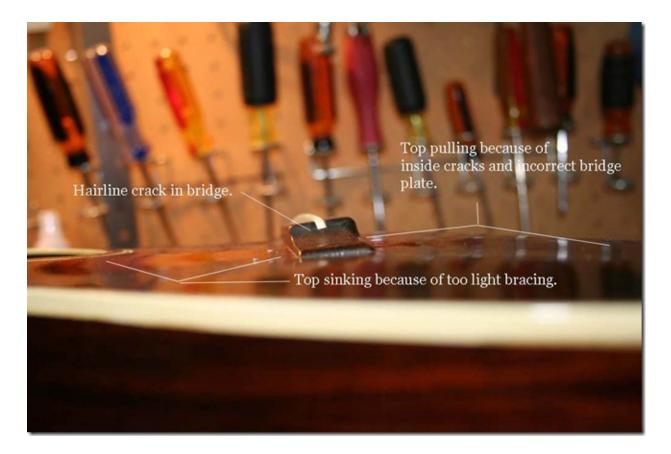
Problem areas

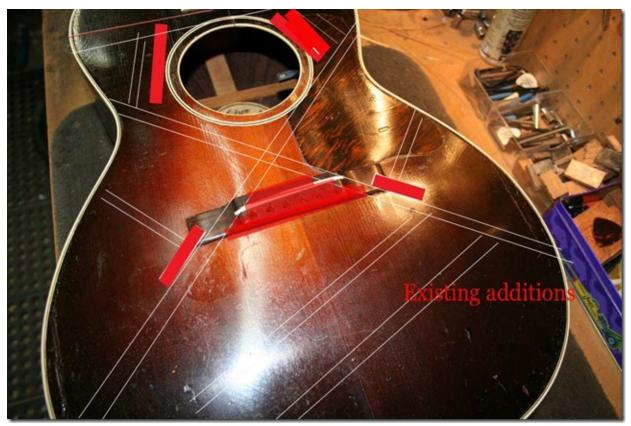
Wes opined that the existing previous brace additions on either side of the sound hole were well conceived and necessary, but were poorly executed and needed to be replaced with more careful attention to detail.

Additions by previous repairs

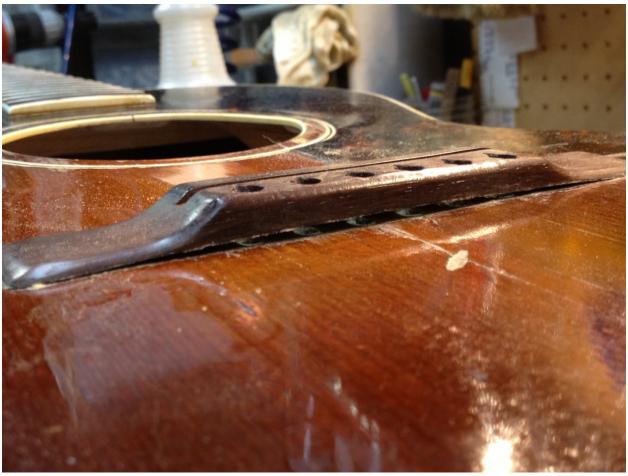
Original rosewood bridge distorted by previous bulge along transverse axis, resting on repaired top. Previous bulge along longitudinal axis was much greater.
